# Unexpected— Earthquake 2011

Lessons to Be Learned

*Edited by  
A. Elena Charola,  
Corine Wegener,  
and Robert J. Koestler*

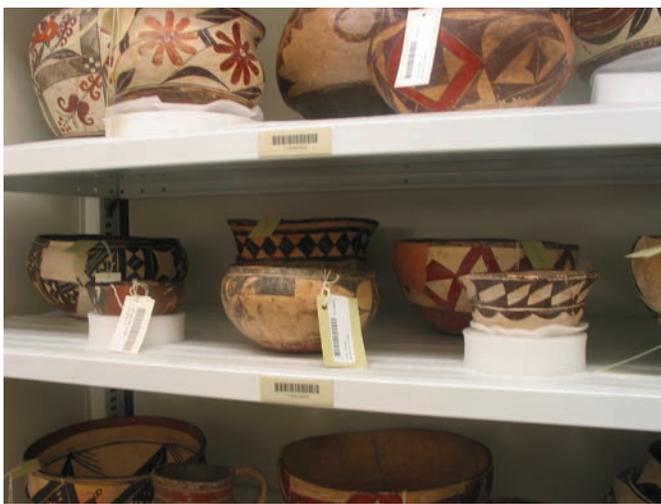
during the second half of the move and benefitted from our own collective reflections upon how best to use cabinet space. With respect to our Southwest ceramics it was determined that they should be decompressed. Rather than being lined up in two rows per shelf, a decision was made to stagger them in a kind of diamond pattern, providing more space between each object so that they could be more easily removed for study and research (F. Pickering, Smithsonian Institution, personal communication, November 2011). In addition, nearly all of these ceramics were fitted with an Ethafoam ring or “doughnut” to stabilize the object on the shelf. While some of these objects actually did tilt in their doughnuts during the earthquake, not a single one suffered damage (Figures 10, 11).

FIGURE 11. Zuni ceramics with stabilizing Ethafoam rings. (Smithsonian Institution photo by David Rosenthal.)

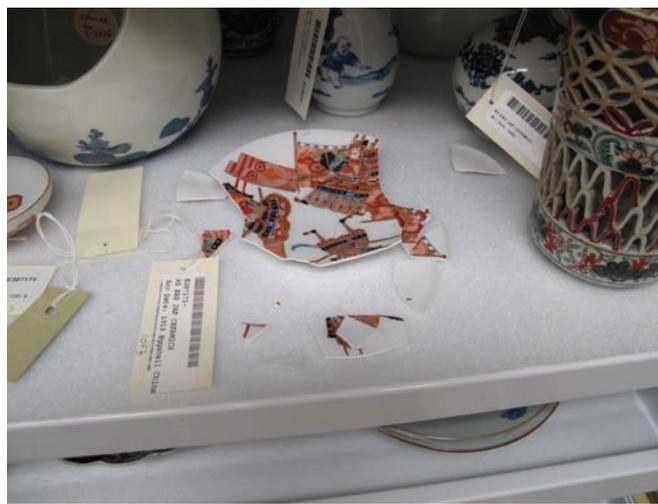
FIGURE 12. Japanese Fujina dish shattered by impact from larger toppled object. (Smithsonian Institution photo by David Rosenthal.)

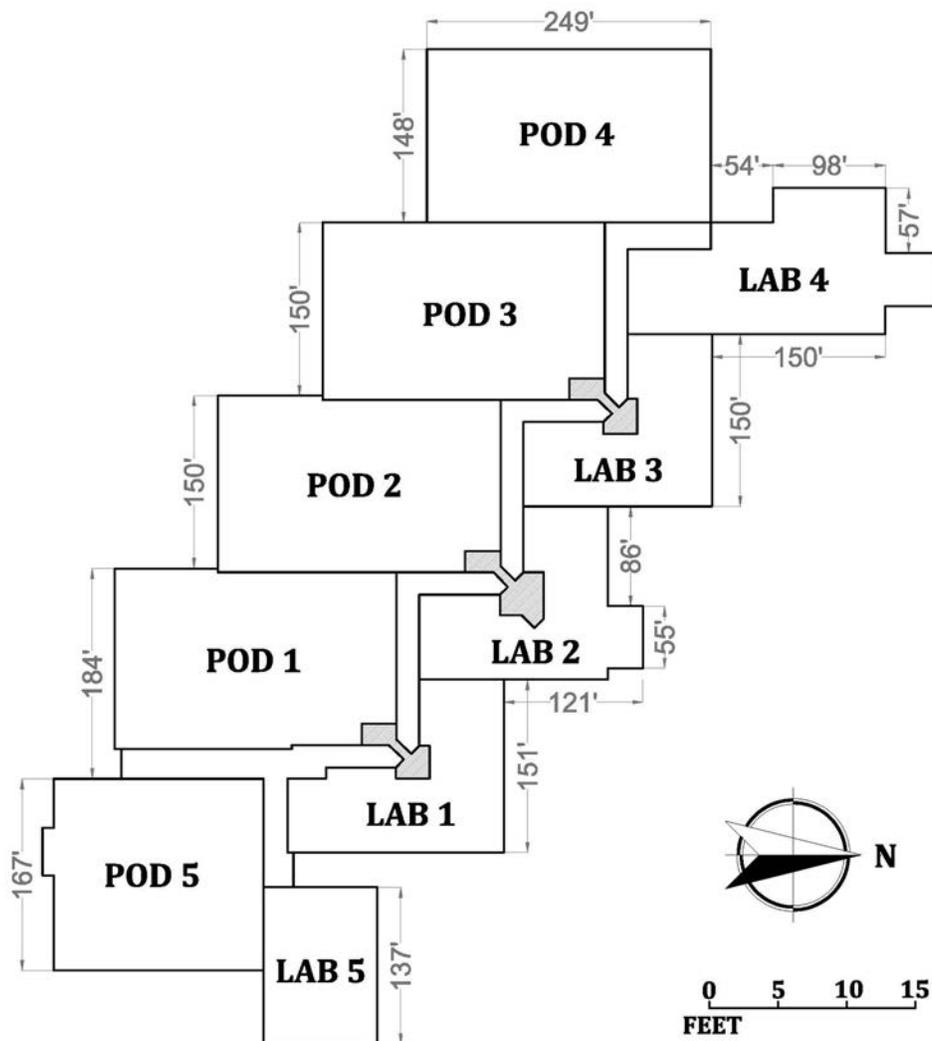
FIGURE 1. Simplified plan of the first floor of the Museum Support Center building showing the relative locations of the five collection storage pods and the associated office, laboratory, and conservation spaces. Numbers are length measurements in feet. Areas marked in grey are stairwells that suffered structural damage. (Drawing courtesy of Yun Liu, MCI Post-graduate Fellow.)

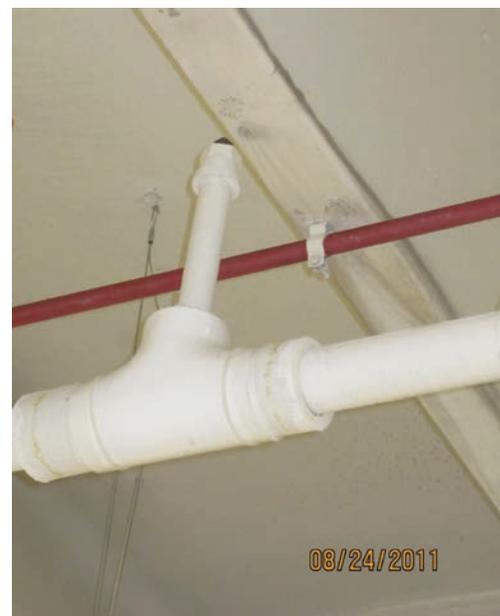
**FIGURE 3.** Above, sprinkler head as installed; right, sprinkler head in Pod 3 sheared off during the earthquake. (Smithsonian Institution photo by Catharine Hawks, NMNH.)

Requests from the HMSG and other units to MSC staff for such supplies surpassed the available stock. Since the earthquake, the cause of the sprinkler head failure has been remedied and the MSC and HMSG have stockpiled additional emergency supplies.

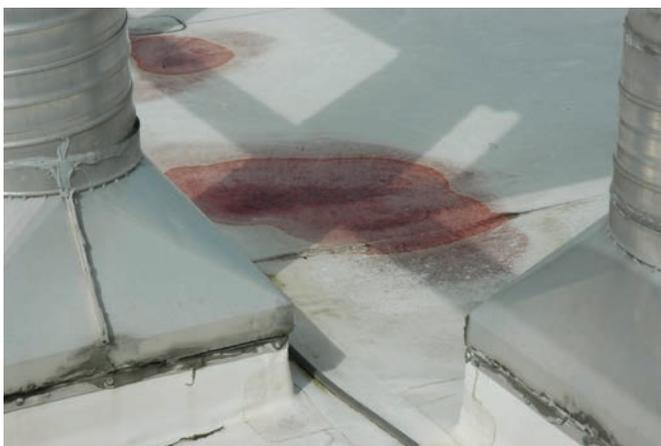
Smaller pools of standing water had collected in other locations across the roof. The bottoms and edges of the puddles often appeared red, green, or blue in color (Figure 9), and in some instances a thicker green-black film was present, all of which suggested a biological origin. Analysis of the green-black film showed the presence of carotene pigments (Madden, internal Smithsonian Institution report, unpublished, 2011) that would be consistent with the presence of algae or bacteria, such as *Trentepohlia* sp. or *Micrococcus roseus*, respectively. Though the organisms were not identified definitively, it was clear that their growth indicated a longer-term problem with standing water in those localized low-lying areas.

FIGURE 9. Red staining in standing water presumably resulting from microorganism growth. (Smithsonian Institution photo by Carol A. Grissom, MCI.)

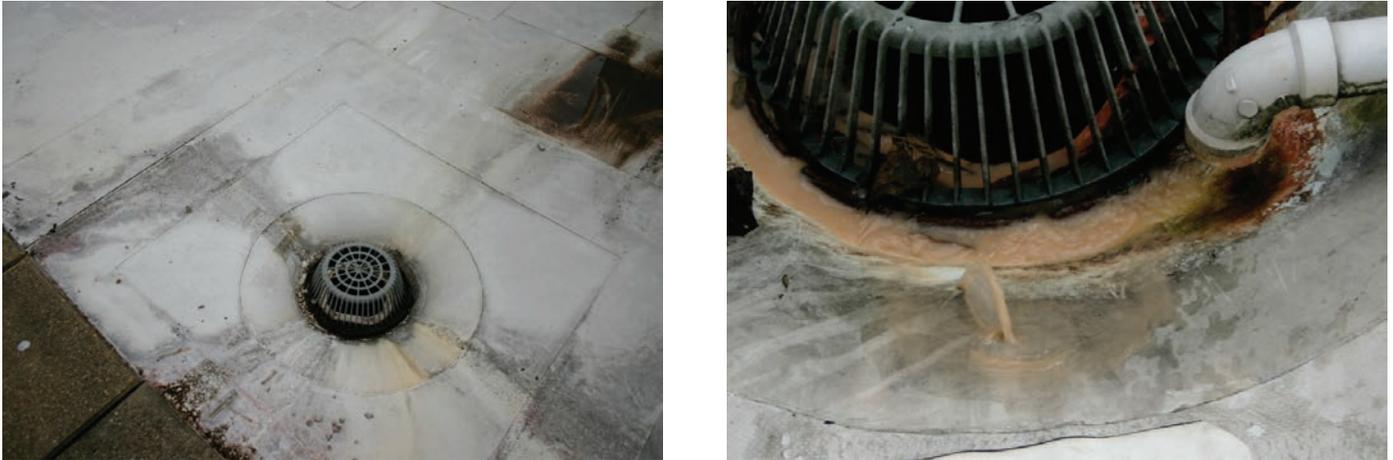
roof membrane by at least 2.5 cm (1 in), and a significant amount of water can collect in the basin without draining. Some of the older flush-mounted drains, including those over the laboratories and offices, also exhibited heavy corrosion on the iron plates that secure the plastic cap. This corrosion was sufficiently bulky to inhibit drainage, and when drains do not shed water effectively the deterioration of the roof membrane may be accelerated.

Because the drains were designed for water shedding off the roof surface, there is no drainage for water that seeps beneath the membrane. This condition was most obvious near the sea of water with floating insulation described above. During the inspection, some small openings (about 5 cm [2 in] long) were cut into the membrane at a nearby drain basin. The water that gushed out was cloudy and white, possibly due to gypsum powder washed loose from the underlying insulation (Figure 10). In essence, the membrane behaved like a bladder that trapped and prevented evaporation of the water that had seeped beneath it.

The condition of the roof membrane, the roof’s uneven slope, and the drainage issues contribute to the accumulation of standing water that makes its way into the MSC buildings through damaged sealing around roof penetrations. The presence of microorganism growth in standing water suggests that drainage has been an ongoing problem on the MSC roof. The original outer roof membrane, which was not removed when the vented roof system was installed, probably continued to offer some protection to the concrete structural roof despite its deteriorated state. It seems likely that the earthquake created new openings in this membrane, which can reasonably be expected to have become brittle with age.

FIGURE 10. Left, typical roof drain in a shallow, membrane-lined basin that may collect rain water and allow it to seep under the membrane; right, a cut was made into the membrane and the water that had collected beneath spurted out. (Photos by Odile Madden.)

if any, were found in the pods, which have far fewer roof penetrations. The prolonged leakage observed in several areas of the MSC building is a reminder that maintenance of flat roof systems with caulked seals is an on-going task.
